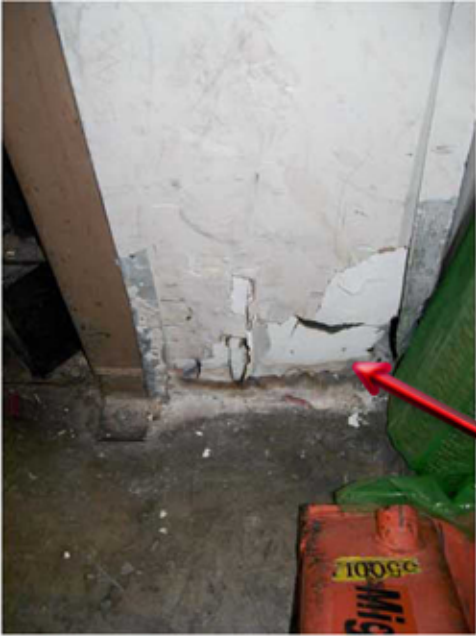
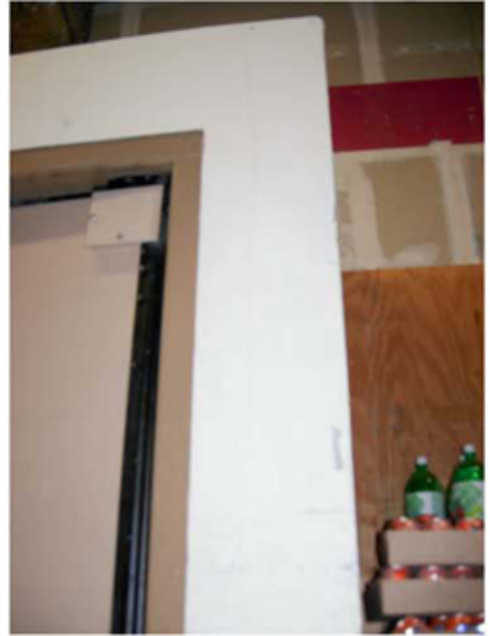
Damaged door frame

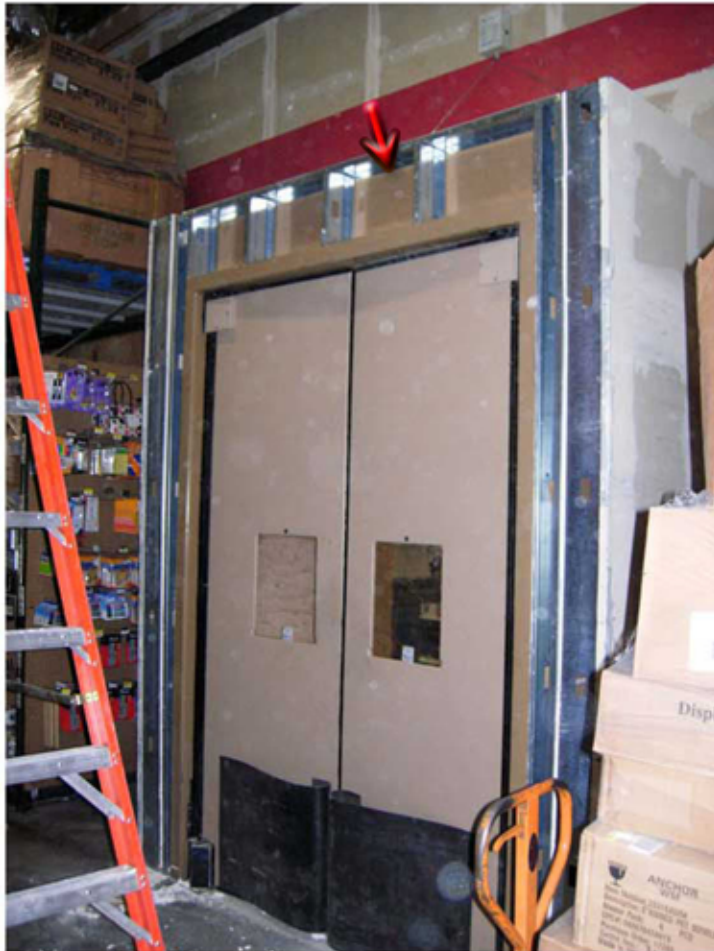
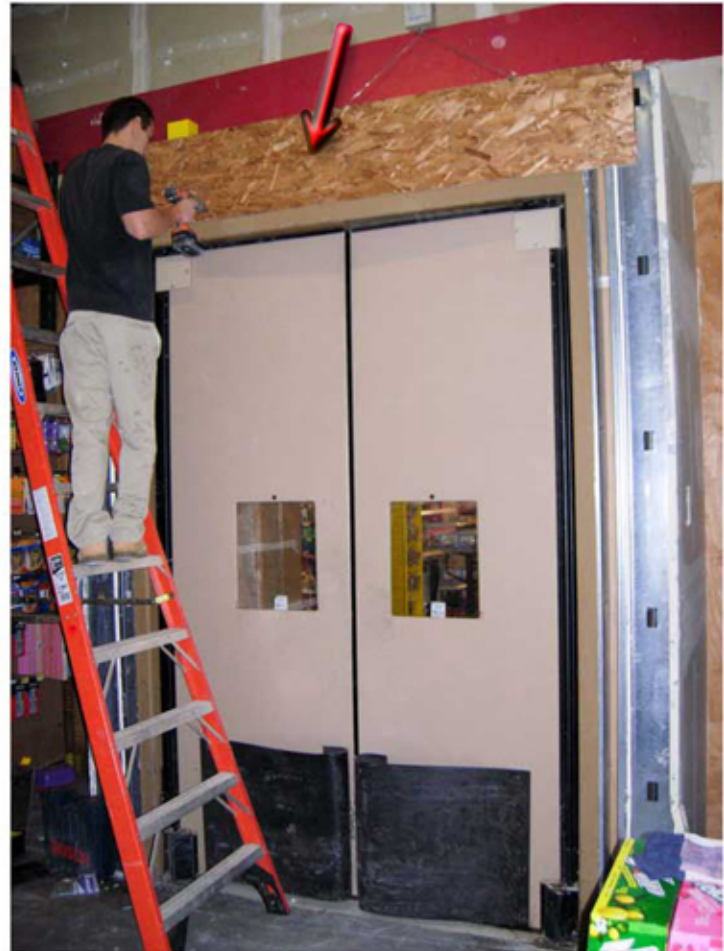
WALL TORN APART FROM FORKLIFT DAMAGE
